Lamanai Historic Monuments Conservation Project: Recording and Consolidation of New Church Architectural Features at Lamanai, Belize

Location: Indian Church, Orange Walk District, Belize

Site: Lamanai

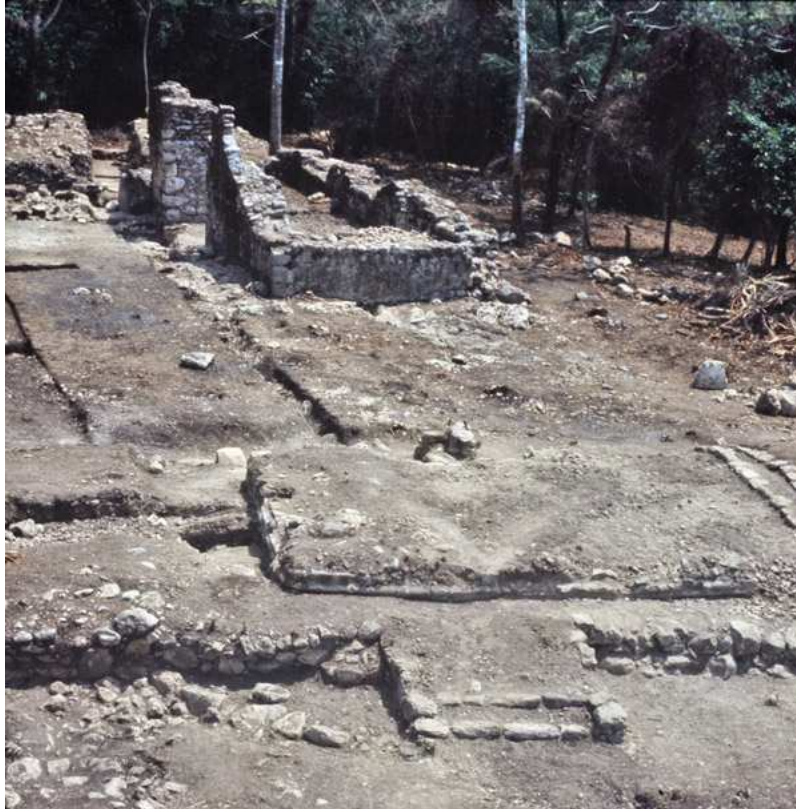
Figure 3. Ruins of the two Spanish churches. The stone chancel-chapel of YDL II is in the background. In the foreground is the central part of YDL I. Visible are the south stair of YDL I, the razed Tulum-style temple over which YDL I was built; and to the right, the steps leading up to the altar/sanctuary. The photo looks north-northeast.

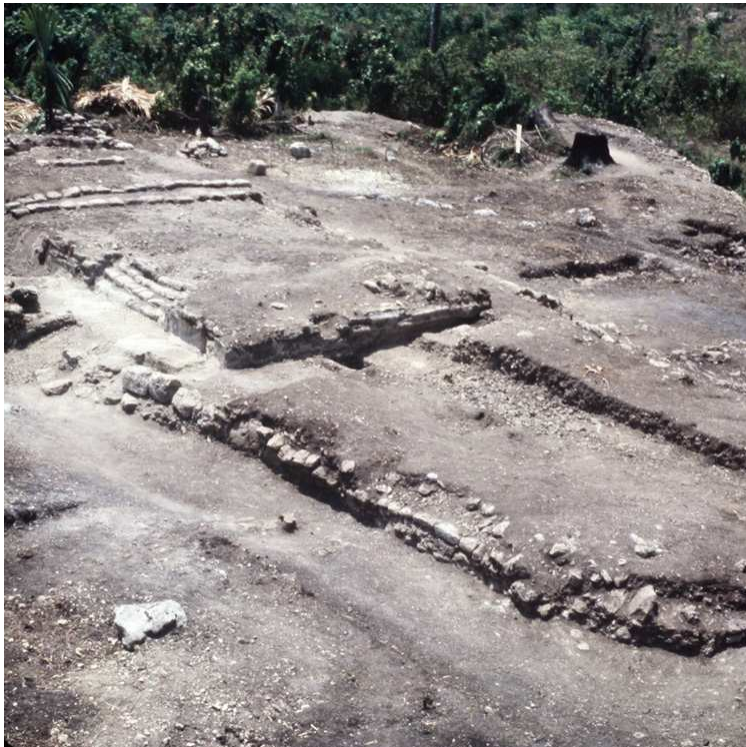
Figure 5. YDL I. The photo looks southeast. Steps leading up to the sanctuary can be seen in the photo's upper left. Also visible are the line of stones on which the (portable) altar pedestal and altar stone were once placed. This line of stones abuts a wall—the only remaining course of the wall can be seen in the photo—that divided the sanctuary from the sacristy.

Figure 16. East end of YDL I, looking west. The space at this end defines what was probably the sacristy—a small room entered through a door in the rear wall of the sanctuary. The rectangular low stone bench (just touched by the tree shadow) abuts the remains of the wall that once divided the sacristy from the sanctuary. In the upper part of the photo can be seen the uppermost line of steps leading to the sanctuary from the nave. The stones that define where the portable altar was placed are more easily seen in [Figure 5](#), in the upper left of the photo.

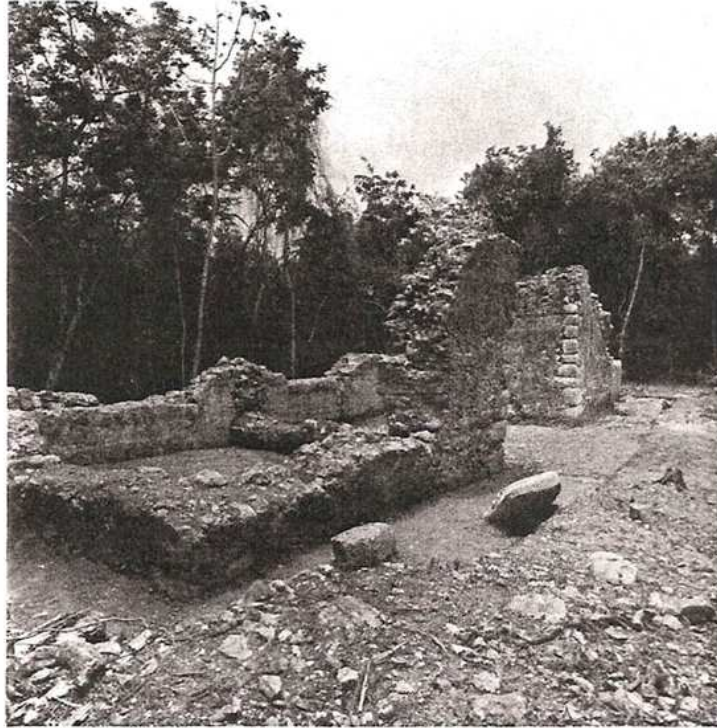
Figure 6. Stone chancel-chapel of YDL II. Not too far from the entrance into the sanctuary stands a stela that was erected in the nave sometime after 1641. The photo looks southeast.

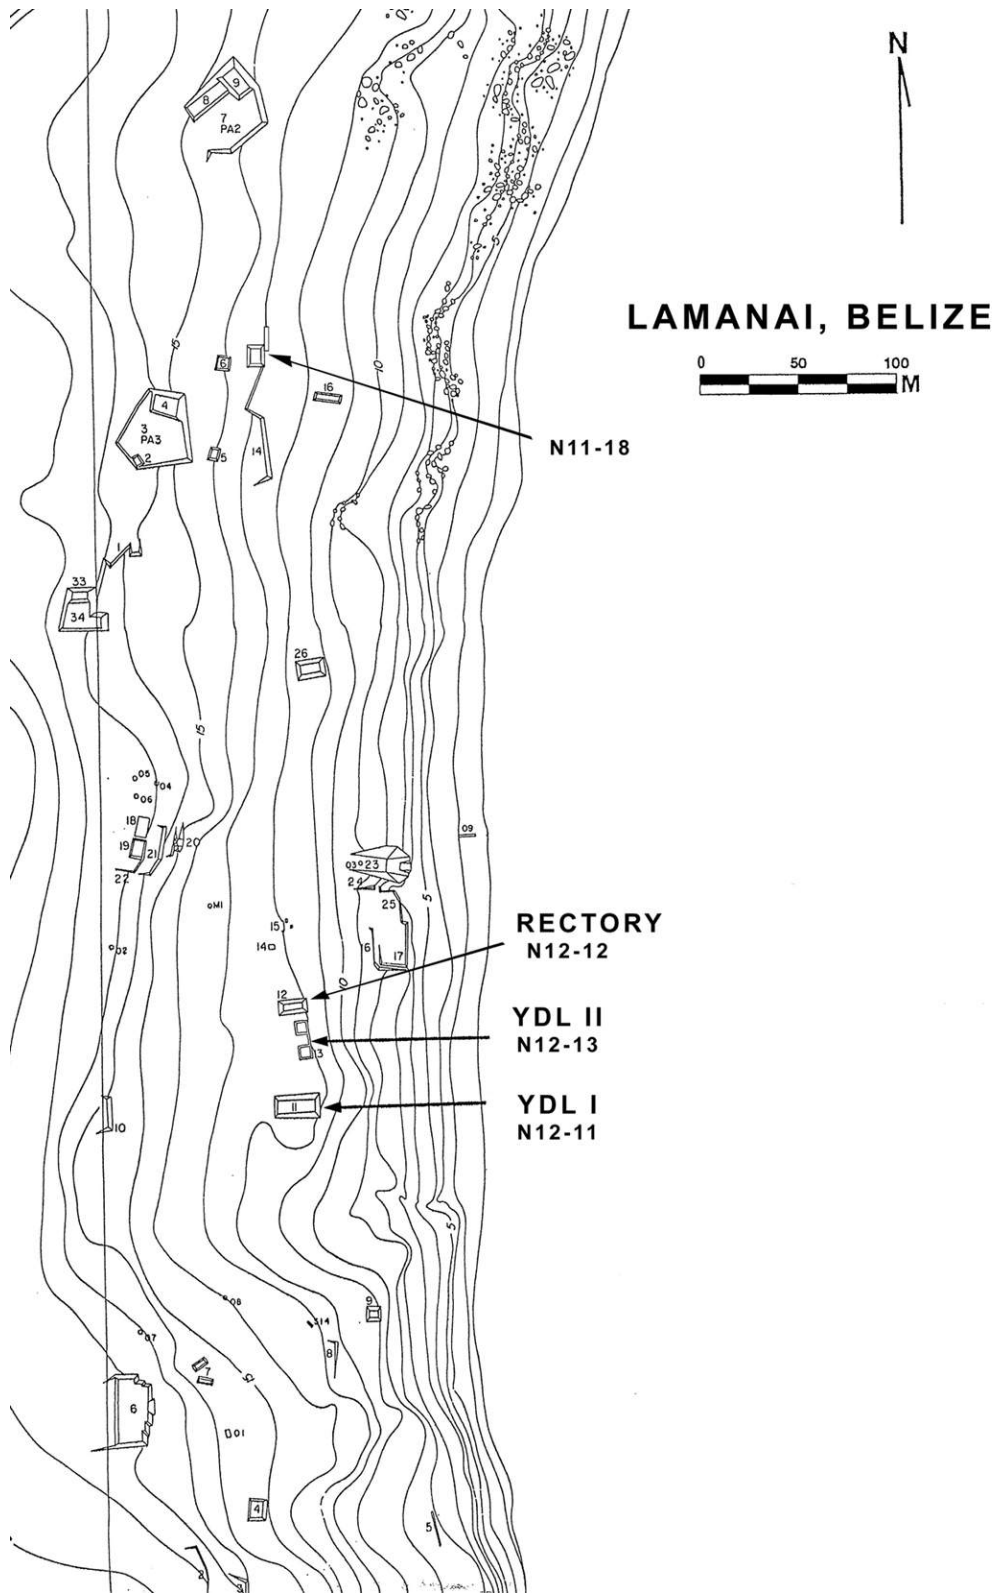
Figure 8. Map of church zone and colonial residential structure to the north of the church zone at Lamanai (see Str. N11-18).

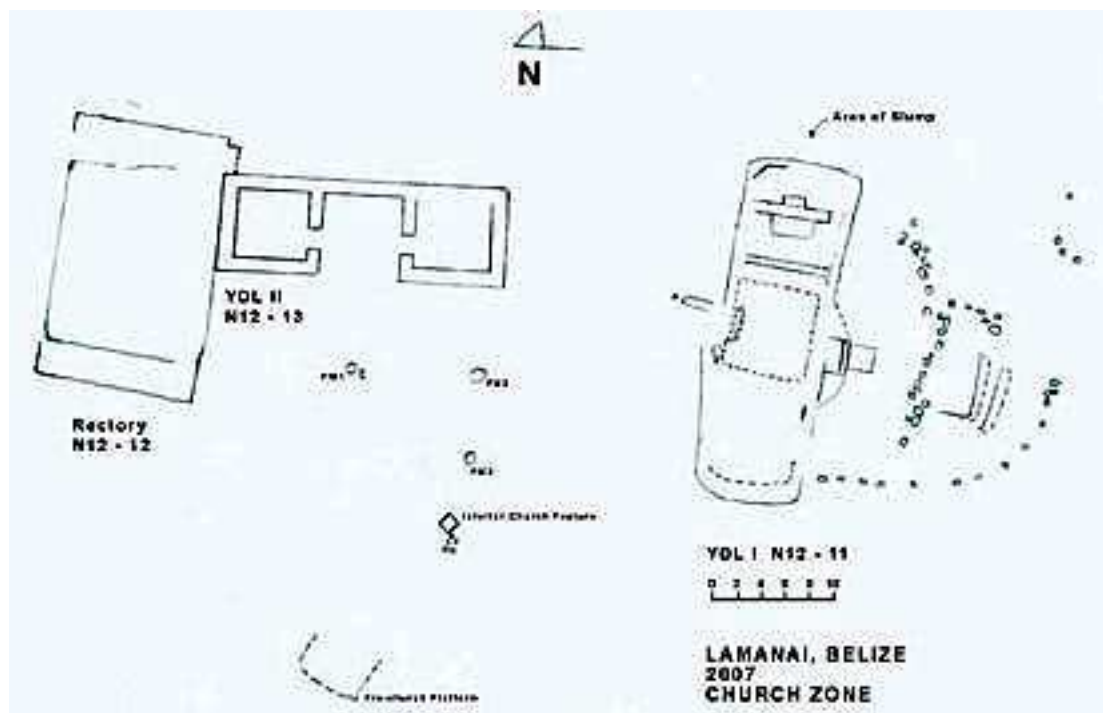
Figure 10. Plan of church zone.

- 8) Clearing of the area south of YDL I revealed a series of low, broad, stone-bordered, descending terraces that formed a patio or *atrio* ([Figure 21](#), [Figure 10](#), [Figure 11](#)). This patio-*atrio* was probably the site for fiestas, masses and other rituals and ceremonies related to the church (McAndrew 1965: 202-231). It would also have been the area used for teaching Christian doctrine or catechism to converts. Patios were sometimes set at different levels to facilitate teaching, with trees planted to shade those who listened, usually groups of children (McAndrew 1965: 211). People would also come to the patios to pray and would kneel there in front of the church door in rows (McAndrew 1965: 209-210 from Mendieta, Tomo III, 156-157). Presumably the friar or priest would stand on the highest level, at the church door.

- 9) There is also evidence of low, curved platforms faced with single lines of stone that stood to either side of the southside stair and served to connect the stairsides to the church platform. The low platform west of the stairside is better preserved ([Figure 10](#), [Figure 11](#), [Figure 21](#)).

- 10) A cache of an effigy vessel (Cache N12-11/3 [LA 3035/1]) was encountered 1.10m north of the NE corner of the north stair of YDL I ([Figure 10](#), A). The effigy—a centipede or lobster-like creature—is hollow and stoppered and has a forked tail. There is a human head inside the creature's mouth. The vessel contained 2 small chert bifaces or points with rounded bases (LA 3035/2,3); a stingray spine in two fragments (LA 3035/4,5); and 3 shark teeth (LA 3035/5,6,7). The effigy is 21 cm in length; the fired clay is reddish in color and has traces of grey-blue stucco paint ([Figure 22a](#), [Figure 22b](#), [Figure 22c](#), [Figure 22d](#)).

- 3) Fragments of a Precolumbian-style censer were found associated with the centerline posthole (see P.H. No. 1, [Figure 10](#); [Figure 25](#)), about 20 cm below the surface. The censer is believed to have been deposited after the church had fallen into disuse, probably after the rebellion of 1638-41.
- 4) A larger platform-like feature, ca. 2m on a side, was found ca. 22m west of the stone chancel-chapel (about 16m due west of the central posthole, P.H. No. 1) ([Figure 10](#)). This feature is believed to pre-date the construction of the church and may well be associated with the Precolumbian structures that were either built over (in the case of YDL I) or intruded upon (in the case of YDL II) by the churches.

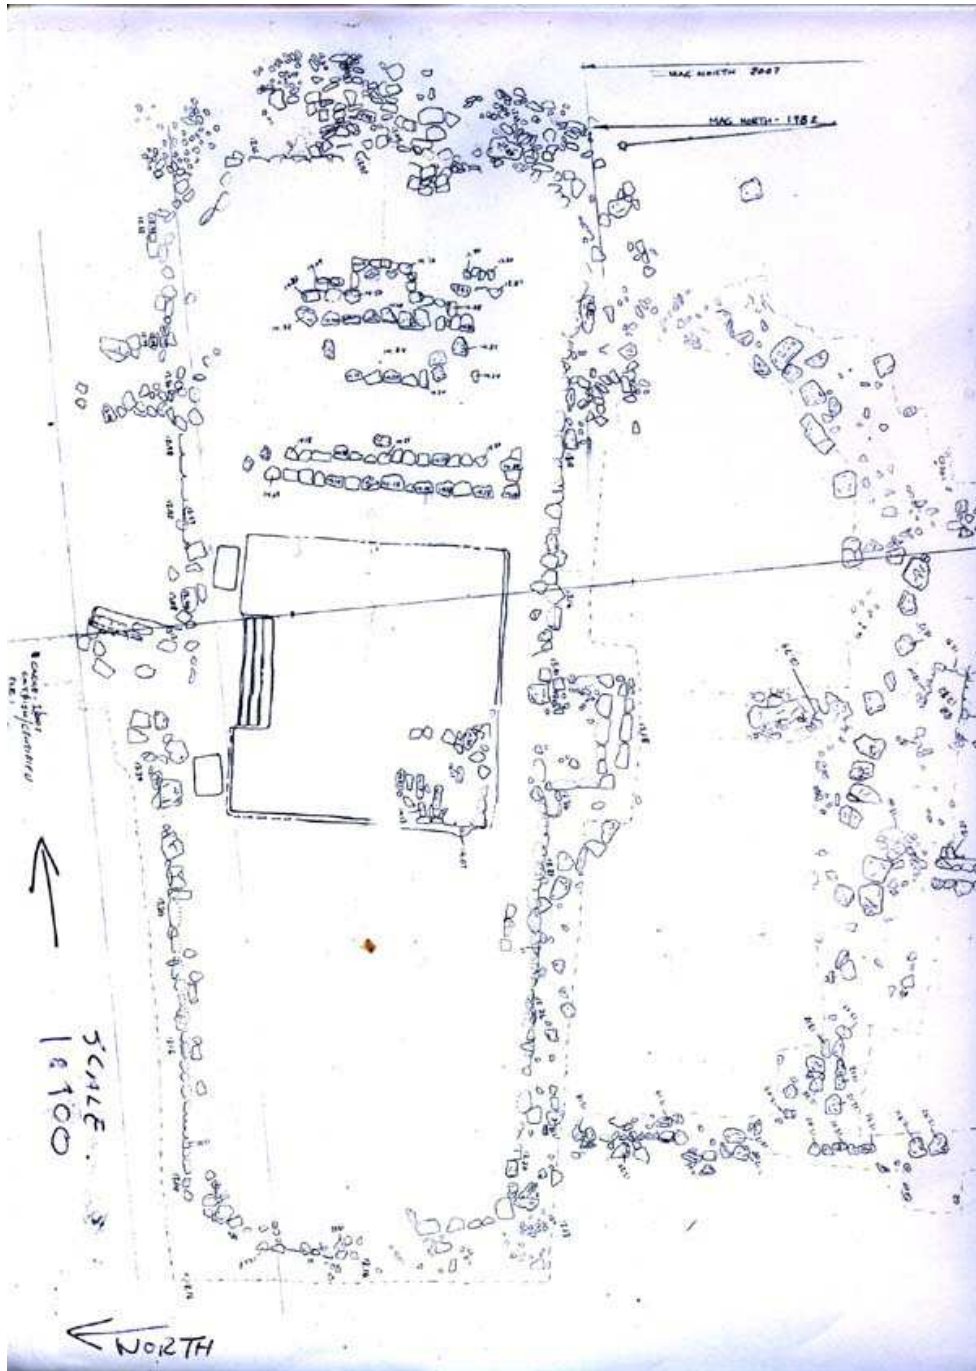
Figure 11. Plan of YDL I and part of the patio-atrio to the south.

- 7) Just inside the south entrance, slightly to one's left as one enters the church, stood a small, low stone feature, possibly a platform, about 1.5m on a side ([Figure 11](#); see also [Figure 19](#)). It originally would have stood higher than the level of the church floor. Three adult and one infant burial—laid out with head to the west in Christian fashion—were found beneath the feature, but they covered an area larger than the feature and are not clearly associated with it. They do indicate, however, that the feature was built after the burials were in place. The feature could have supported a font or a statue or internal church furniture of some kind.

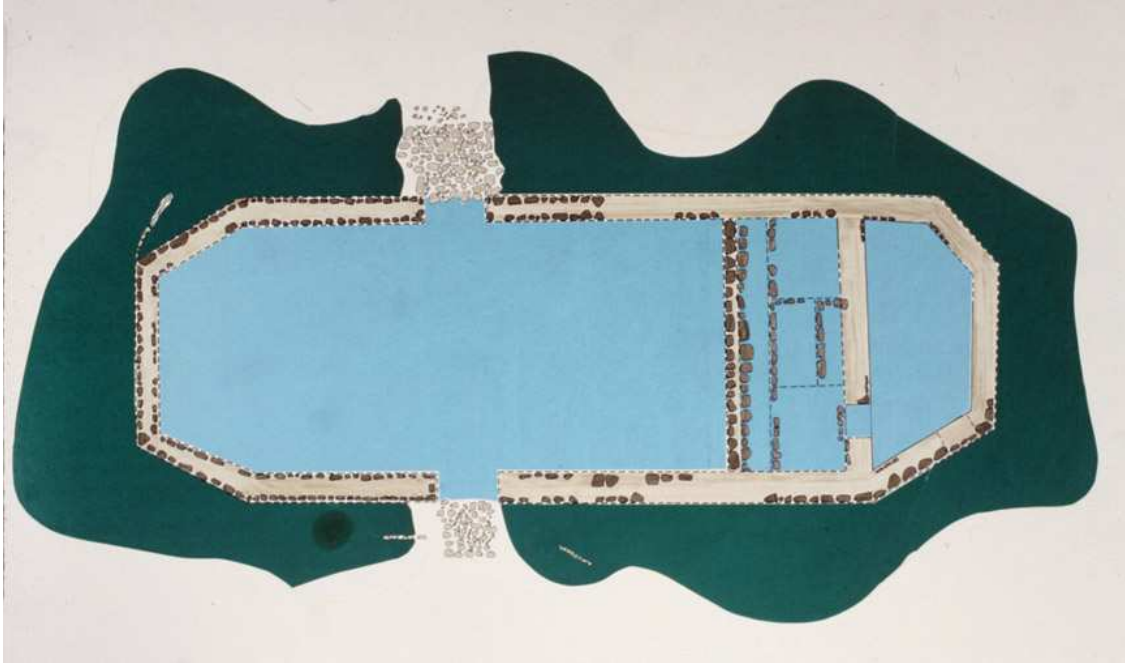
Figure 12. Plan of the church at Tipu. East is to the viewer's right.

- 1) *Apsidal/polygonal east end of church:* Very little collapse debris from the partial-height stone walls of the church superstructure remained. However, a polygonal section forming the base of the wall was recovered at the northeast "corner" ([Figure 10](#), [Figure 11](#)). A remnant of the wall had been cleared in earlier years by Pendergast on the south side of the church, west of the entrance approached by the south side stair ([Figure 10](#), [Figure 11](#)). It is not clear whether the church superstructure at Lamanai had a polygonal west end. The church at Tipu was polygonal at both its east and west ends ([Figure 12](#)).

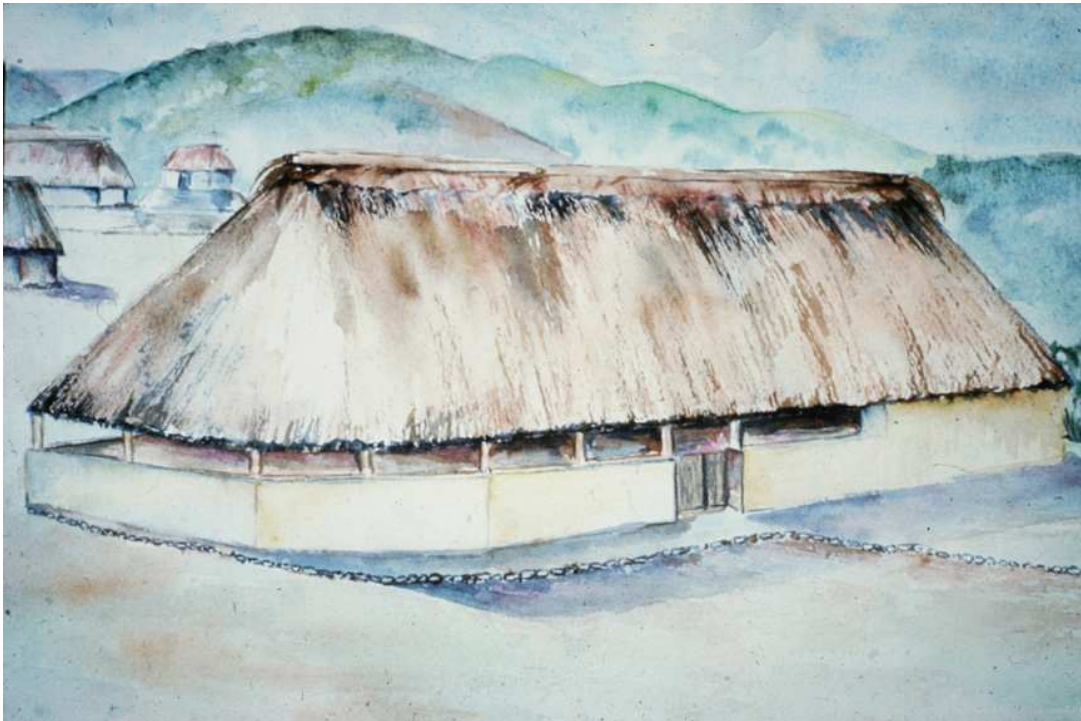
Figure 13. Reconstruction of the Tipu church, looking north-northeast. The blind sanctuary is at the east end. (Painting and reconstruction by Claude and Louise Belanger.)

the masonry base, although the remainder of the church walls could have been open, as suggested for Tipu (Figure 13), to allow ventilation. Because church paraphernalia would have been kept in the sacristy and used in the sanctuary during mass, and also because very strong breezes blow off the New River Lagoon from the east, it is likely that YDL I's east end would have been built with full-height walls (lower part stone, upper part poles).

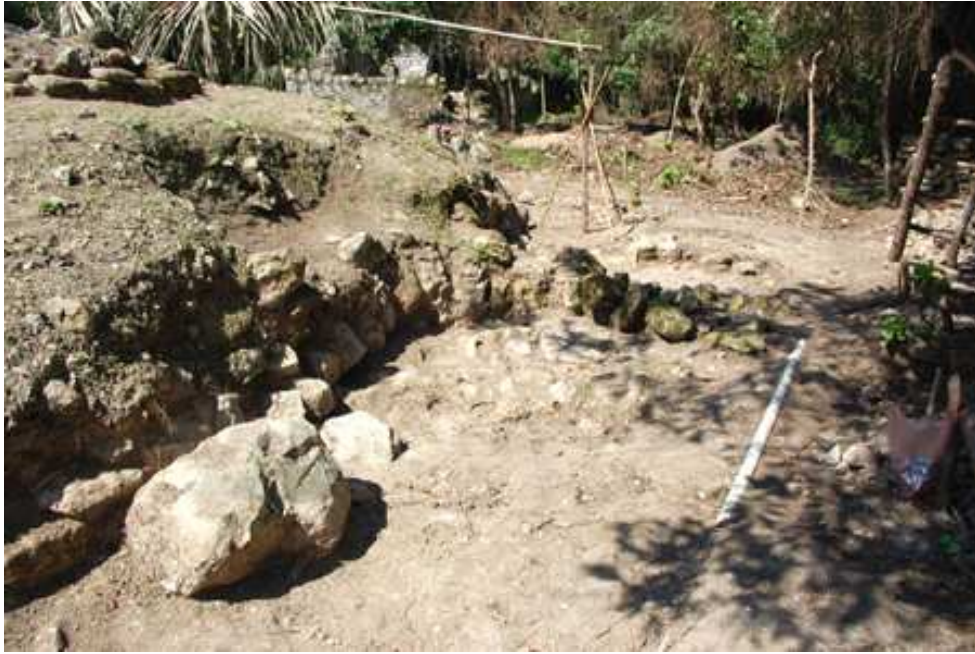
Figure 14. East end of YDL I showing a section of the shoring of slumping platform face on this side. The photo looks north.

- 4) *Bad planning by Franciscans?* Clearing on the east side of YDL I revealed considerable slumping and instability of the church platform and walls at this end—so much so that the platform faces had repeatedly to be shored up by the Maya on this side ([Figure 14](#), [Figure 15](#)). If local advice had been provided concerning the limits of the limestone bedrock that would satisfactorily have supported the church's foundations, then this advice was ignored by the Spaniards.

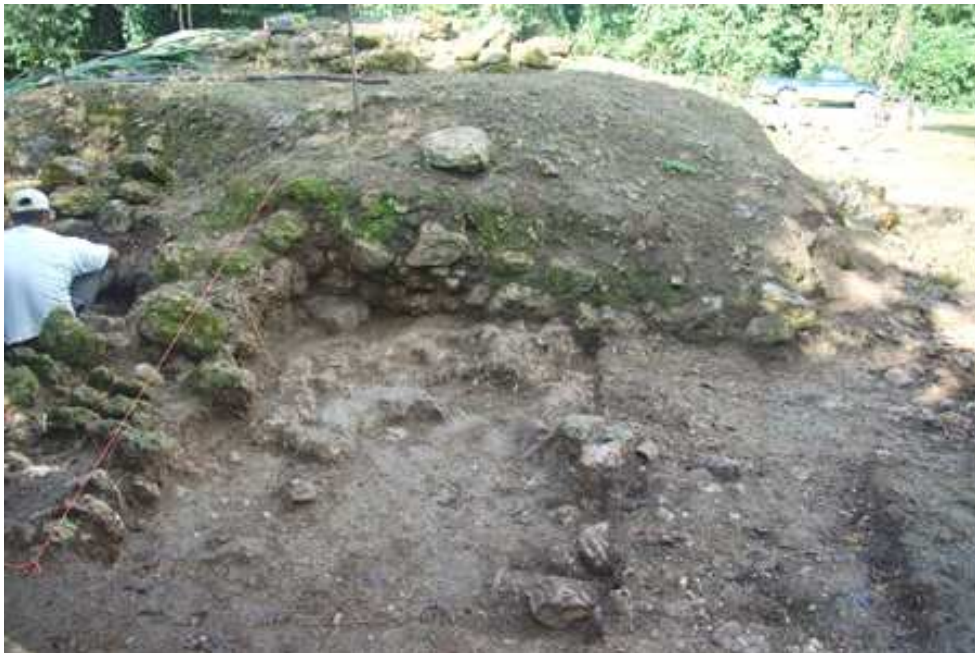
Figure 15. East end of YDL I, looking west, showing part of the remaining platform face on this side and the shoring to the viewer's left.

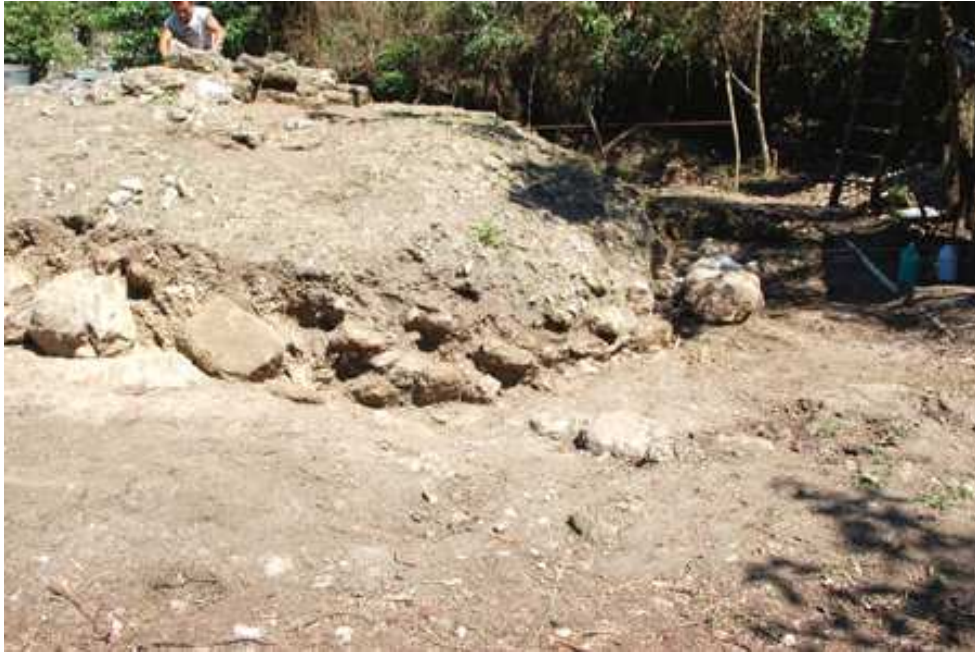
Figure 17. North and east sides of church platform showing the remains of the polygonal facet.

- 5) *Identities with Tipu church*: Full clearing of the altar and sanctuary end of YDL I revealed that it was almost identical to the altar and sanctuary of the Tipu church:
- a. A single room existed to the east of the sanctuary and probably served as the sacristy ([Figure 16](#)).
 - b. Lines of stone abutting the wall that divided the sanctuary from the sacristy served to guide the placement of what was probably a wooden and portable altar ([Figure 11](#)).
 - c. The doorway leading from the sanctuary into the sacristy was south of the altar.
 - d. Excavation of the east end of the YDL I platform revealed evidence of a polygonal form, suggesting that the platform that supported the church was also polygonal (as was the church superstructure itself) at its east end ([Figure 17](#), [Figure 18](#)).

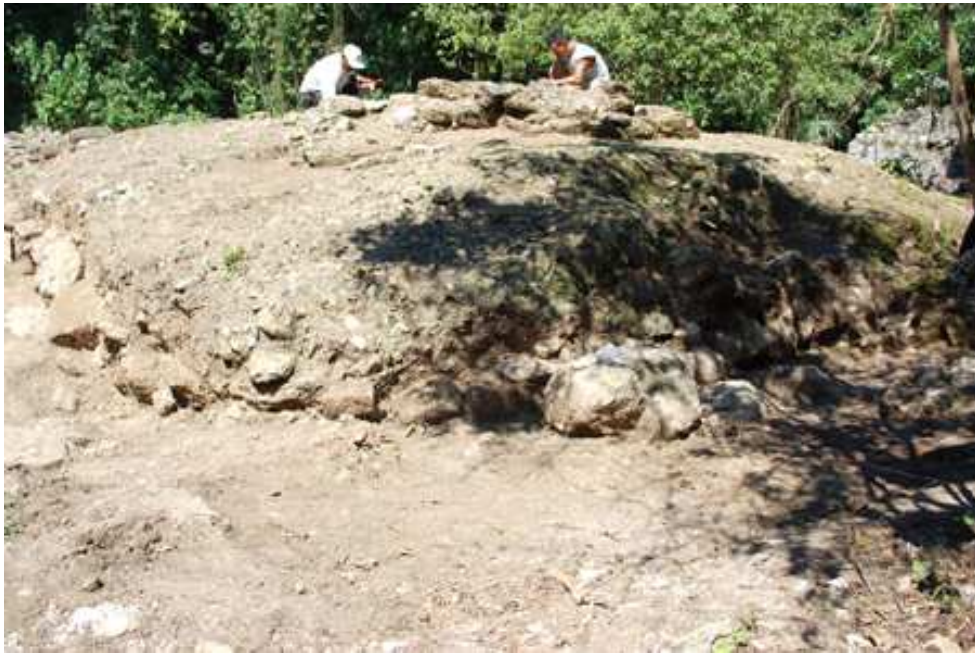
Figure 18. Same view as [Figure 17](#) with more exposure of the east end, showing the remains of the polygonal facet of the church platform.

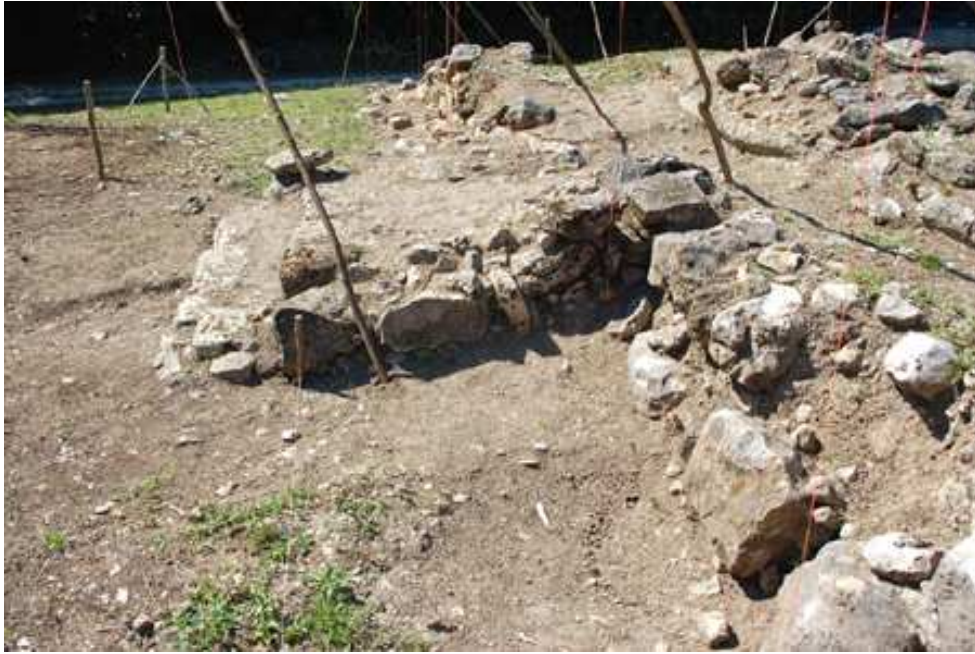
Figure 19. Clearing the south stair of YDL I. The photo looks west.

- 6) Clearing of the areas around YDL I revealed the full extent of the stair on the south side ([Figure 19](#)), and that a burial (of an adult) had been placed in a stone-lined unit abutting the stair at the junction between the west stairside and the church platform face ([Figure 20](#)). The burial was left in situ.

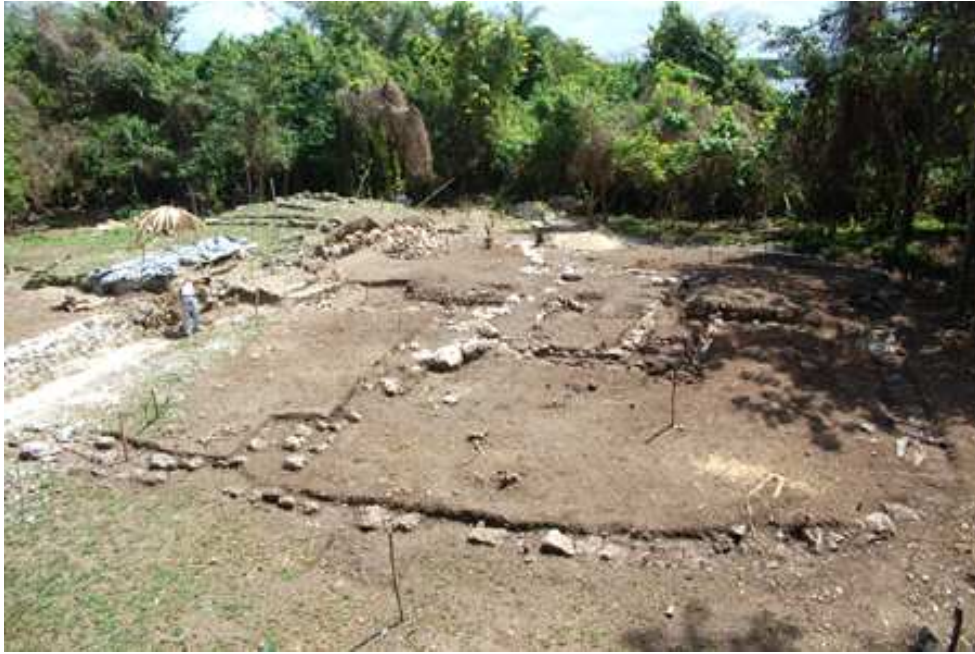
Figure 21. Patio-atrio on the south side of YDL I. The photo looks east toward the lagoon.

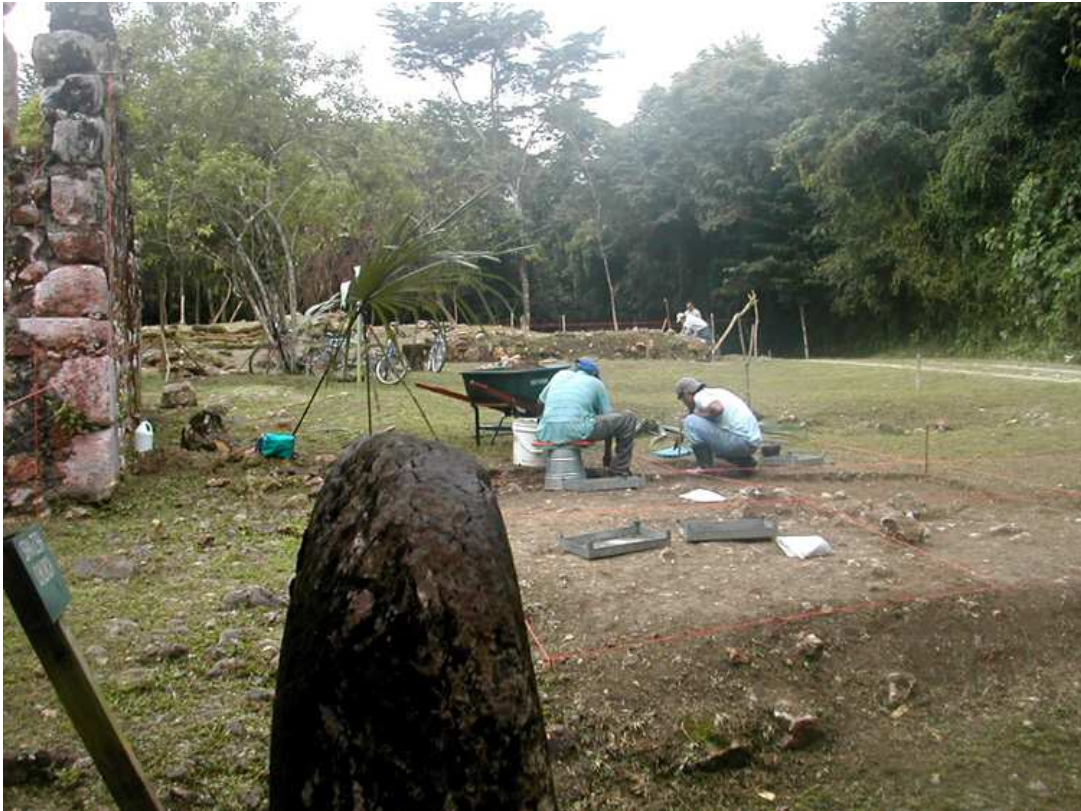
Figure 24a. YDL II, clearing the nave. The photo looks south.

- 1) Clearing in the area of the nave (west of the stone chancel-chapel) revealed three postholes. One represents a post that supported the thatched roof on the church's south side ([Figure 10](#), P.H. 2); one is for a centerline post ([Figure 10](#), P.H. 1); and one supported the roof at the southwest corner ([Figure 10](#), P.H. 3). Based on post locations, the dimensions of the church nave are projected at 17m x 19m ([Figure 10](#), [Figure 24a](#), [Figure 24b](#), [Figure 24c](#)).
- 2) Also uncovered was a rectangular feature, a small platform, approximately 1m on a side. It was found in what would have been the southwest corner of the interior of the nave ([Figure 10](#), [Figure 24c](#)). The platform comprises some sort of church element and could have supported something like a holy water font or saint's image. One majolica fragment was recovered from the feature.

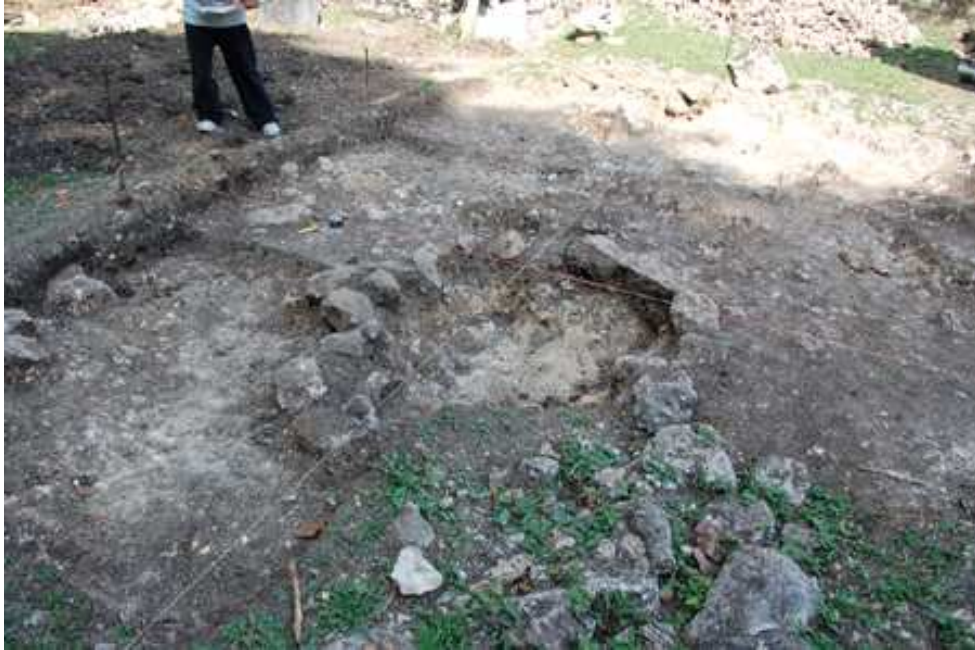
Figure 24b. YDL II, center-line posthole. Stone chancel/sanctuary is at the top of the photo. The photo looks east-northeast.

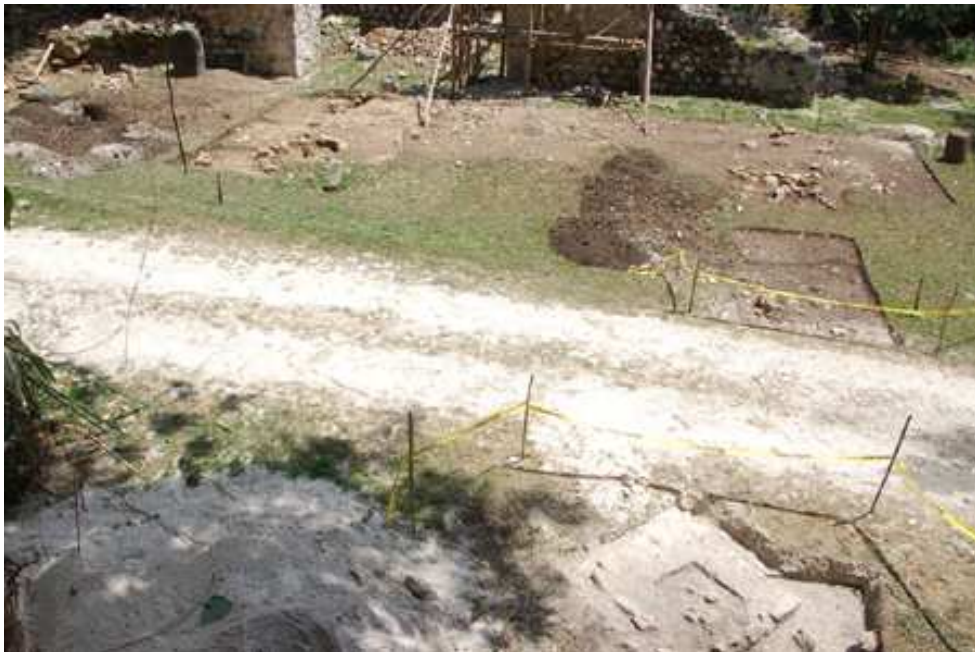
Figure 24c. YDL II, view of the nave looking east. The center-line posthole can be seen at the photo's top left, just west of the entranceway to the stone chancel-chapel; the south-line posthole is in the top right of the photo just west of the corner of the stone chancel-chapel; the platform feature that once stood inside the nave at its southwest corner is in the bottom right of the photo.
